CF6 HIGH PRESSURE COMPRESSOR AND TURBINE CLEARANCE EVALUATIONS

M.A. Radomski and L.D. Cline
General Electric Company

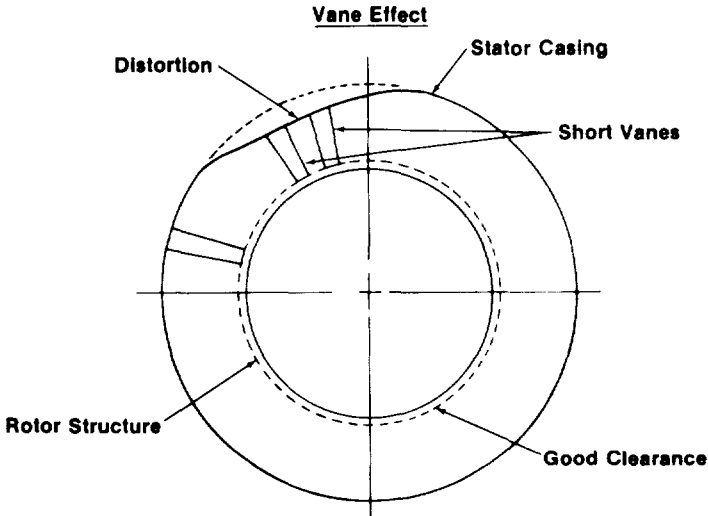
FIGURE 15

Compressor stator casing out-of-roundness has been found to be the most significant cause of airfoil tip clearance degradation in revenue service engines. The effect of casing out-of-roundness on compressor blade and vane clearances is shown in Figures 14 and 15, respectively. To meet the minimum clearance at build-up, all blade tips have to be machined shorter by the amount equal to at least the inward distortion. Vanes, on the other hand, only need to be machined shorter in the area of the inward casing distortion.

Effect of Casing Distortion

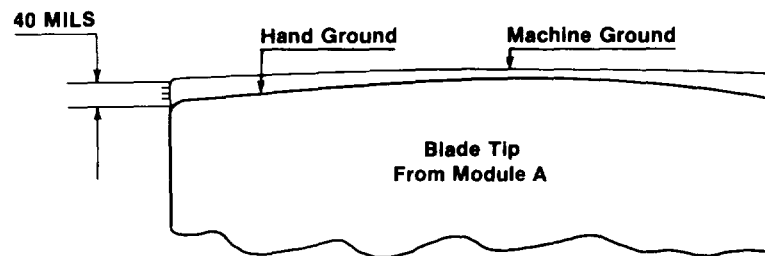
FIGURE 17

The field shop practices involving out-of-round casings at engine build-up require that the individual compressor rotor and stator casing modules are machined to meet a target minimum clearance. However, verification of the actual minimum clearance is required, and this is accomplished by applying wax strips of known thicknesses to the stator casing and rotor spool lands and then installing the casing halves around the rotor. The rotor is then rotated through 360° after which the stator casing halves, upper and lower, are removed and the wax strip thicknesses are measured. If the wax strips were rubbed, indicating below minimum clearance, then the airfoil tips are hand ground to correct this condition. How the magnifying effect on clearances is produced will be illustrated by a specific field engine incident. An engine that failed to meet the minimum performance standards was disassembled and inspected. Inspection of the compressor, which had been refurbished prior to the test cell run, indicated out-of-roundness in the stator casing which is shown in Figure 16. The rotor blade tips in the aft end of this compressor were rounded off by hand grinding at assembly, because of below minimum clearance due to the out-of-round stator casing. A rounded-off blade tip from this compressor is compared to a machine ground blade tip from another compressor in Figure 17. The casing out-of-roundness in the aft end was a maximum of 20 mils, but the blade tips were up to 40 mils shorter at the leading and trailing edges. This is a good example of how the effects of an out-of-round casing on the average clearances are magnified. Hand grinding is not acceptable for this purpose. A procedural change has been specified to require remachining rather than hand grinding in similar cases.

Hand Grinding of Blade Tips at Assy

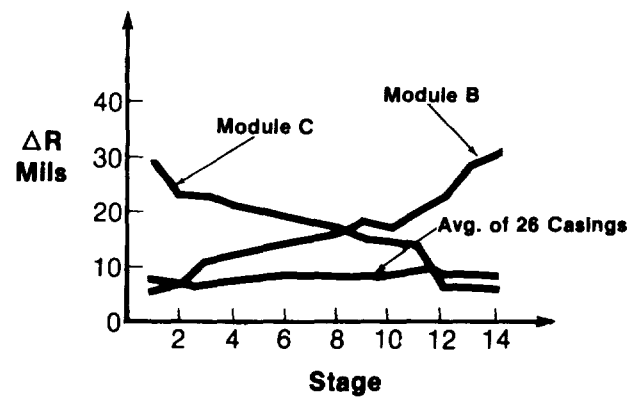
FIGURE 18

Out-of-roundness data from a survey of twenty-six stator casings are summarized in Figure 18, where three sets of values are shown, i.e., the average of all measured and the largest measured in modules B and C. Although the average values were only about 10 mils, the maximum values were as much as 30 mils. Out-of-roundness of the module B stator casing, in particular, had a very significant impact on performance, since the clearances in the aft end of this module had to be increased by at least 20 to 30 mils. To avoid this large performance penalty, field procedures have been specified for the repair of casing out-of-roundness.

Casing Out of Roundness vs Stage

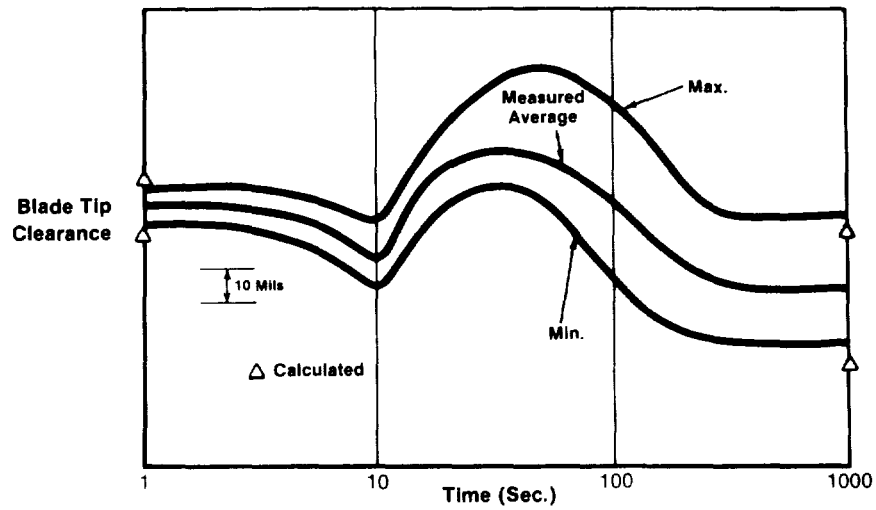
FIGURE 27

Evaluating the results of each of the individual clearanceometer probes relative to the averaged data for any given time yields a measured "out-of-roundness." These data were then used in conjunction with calculated mechanical loads and calculated thermal distortions to identify deficiencies, and they formed the basis for correction of the calculated results. Out-of-roundness results are shown in Figures 27 and 28 for throttle bursts and chops respectively.

Stator Out-Of-Roundness — Throttle Burst

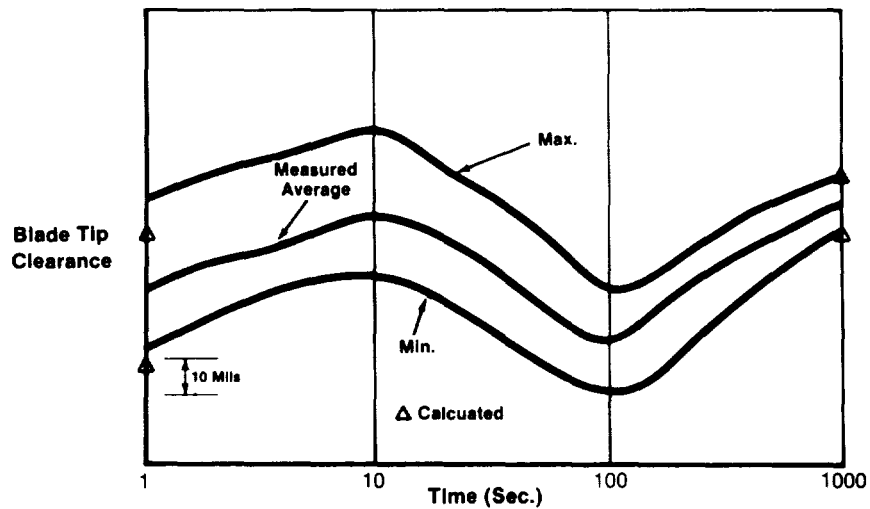
FIGURE 28

Stator Out-Of-Roundness — Throttle Chop
